PowerWorx Front Access Fuse Panel Replacement

PN # TFC-WORX-FAM1
PowerWorx Front Access
Fuse Panel Replacement
(Equiv. to ADC # TFA-FAM)

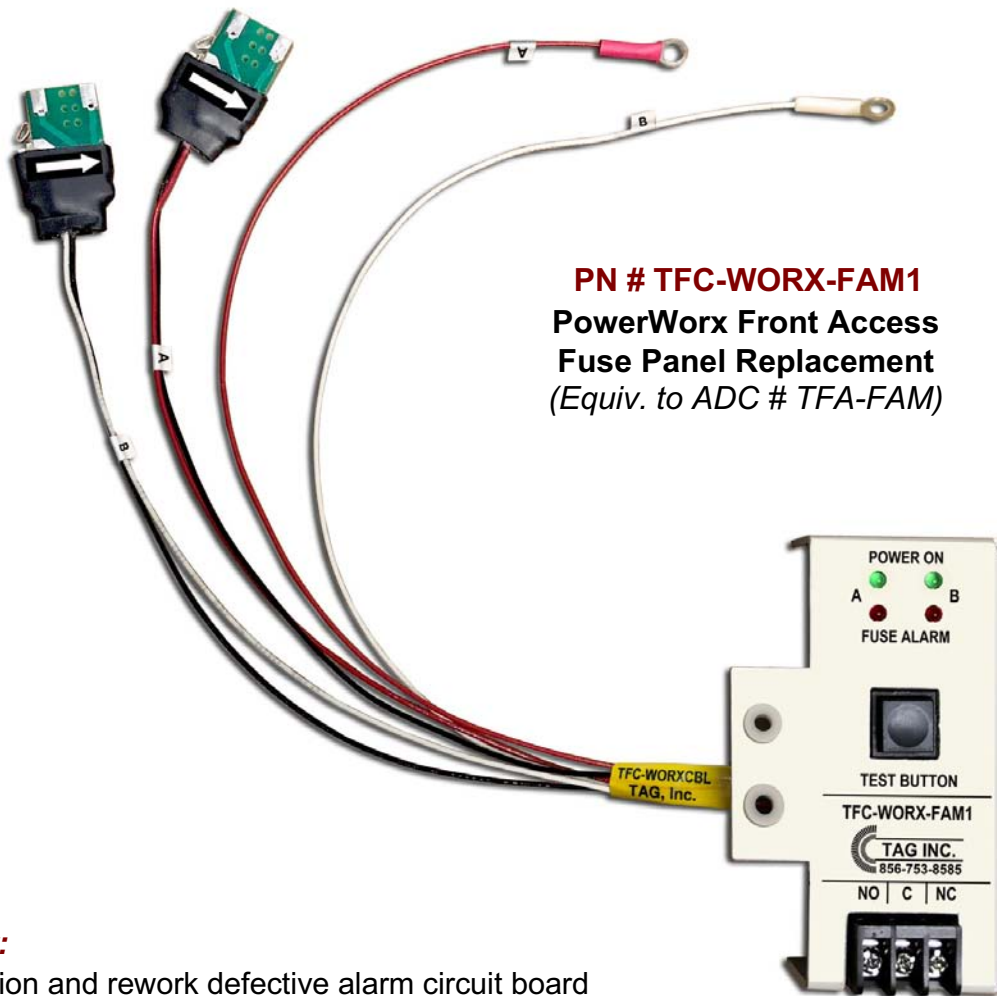
Identification and rework defective alarm circuit board
in the PowerWorx Fuse Panel (PWX-002FGCSD10PWDP)

Defective Alarm Circuit Board in the PowerWorx Fuse Panel incorrectly sets remote power alarm. Alarm contact closure has a dead short across normally open and common contacts indicating power distribution or power bus trouble. This problem only affects the ability to monitor local or remote alarms in the ADC PowerWorx distribution panel.
